The fate of number 13

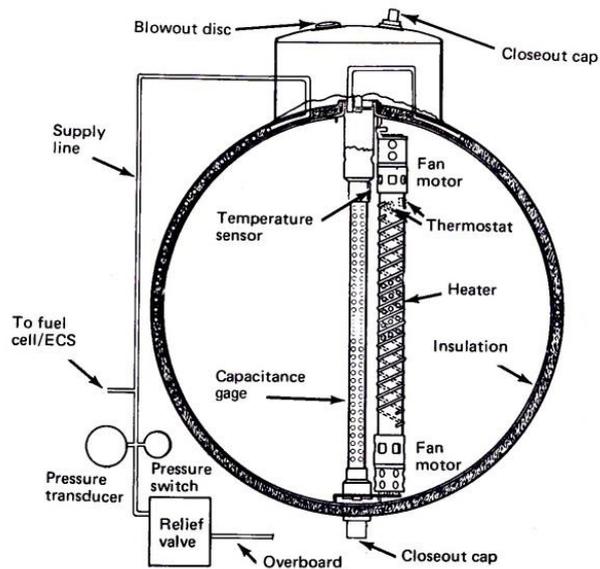
Beechcraft was the manufacturer of the LOX (liquid oxygen) tanks that were mounted inside sector 4 of the Service Module. They comprised a couple of fans with their respective motors, a heater to augment pressure if necessary and a temperature sensor all of which worked at 28 VDC. Obviously, they all had to be replaced with 65 VDC elements.

During the process of the substitution of the old parts for the new ones, one of the tanks fell to the floor from a high stand. It was one of the assigned to the Apollo 10 flight and it was immediately substituted by other until checks proofed no damage was present.

Oxygen tank number 1 went through the sequence with no problems, but tank number 2 (the one originally assigned to Apollo 10) didn't purge below 92%. High-pressure gas was used to try to clean the supply lines and relieve valves but the results were anything but successful.

As the switches had been connected at 65 VDC (*37 VDC more than what they were meant for*) during such a long time, the contacts melted and the heaters remained ON permanently increasing the temperature and, thus, the pressure such that the relieve valves could hardly maintain integrity. Moreover, the heat damaged the Teflon insulation of the cables. ⁽²⁾

However, reality was that LOX tank number 2 (YES, the one that had had all previous problems) had experienced a rupture due to an increase of pressure that went over the limit. Due to this situation, the tank itself broke open and thus, the oxygen inside expanded rapidly fulfilling the zone where the fuel cells were located. (*Sector 4*).
